# Home Inspection Report

Mark Bunch / Measure of Confidence In-  
spections LLC

HOME INSPECTION REPORT

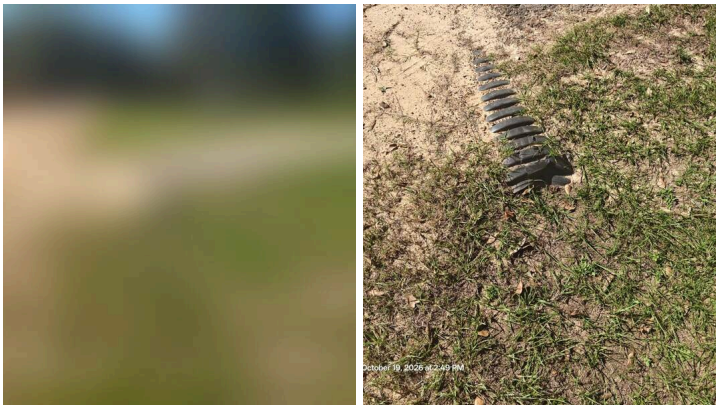
The culvert/ditch drainage area in front of the home was not adequately dug out and does not appear capable of functioning as intended. When this drainage path is too shallow, obstructed, or poorly shaped, stormwater may not flow away efficiently and can pond near the roadway, driveway, or front portion of the property. Poor surface drainage can contribute to saturated soils, erosion, driveway deterioration, ice buildup in cold weather, and increased moisture conditions around the property. This type of drainage feature may be located within a municipal or public right-of-way, and responsibility for maintenance can vary depending on local jurisdiction and property boundaries.

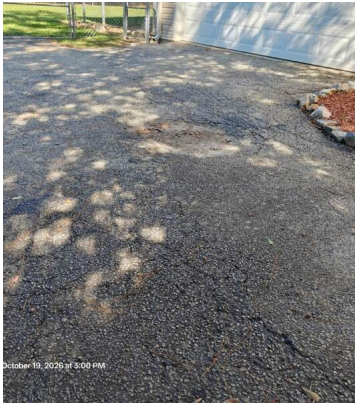
Asphalt Driveway Deterioration and Cracking

The asphalt driveway surface showed visible deterioration, including areas of cracking, surface wear/raveling, and prior patching/unevenness. These conditions are commonly associated with age, weather exposure, and movement/settlement of the base material below the driveway. Cracks and low/uneven areas can allow water to penetrate beneath the asphalt, which may accelerate further deterioration, especially during freeze/thaw cycles. Recommend evaluation by a qualified asphalt contractor for repair options. At minimum, cracks should be cleaned and sealed and deteriorated/uneven areas should be patched as needed to help slow further damage. If deterioration is widespread or the base is unstable, resurfacing or replacement may be necessary. Monitor the driveway for continued settlement, ponding water, or worsening cracks.

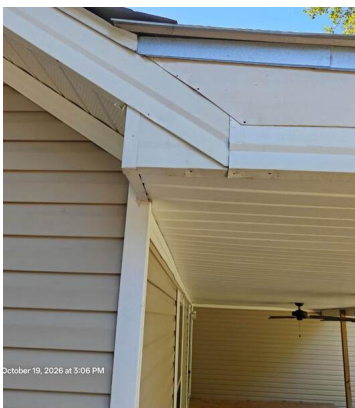
Unable to verify porch roof connection to home

The porch roof connection to the home was concealed by finished/closed-in materials, so the method of attachment, flashing, and structural support could not be visually verified during the inspection. This area is important because the connection must properly transfer roof loads to the structure and help prevent water intrusion where the porch roof meets the exterior wall. Concealed connections can hide conditions such as inadequate fastening, missing or improper flashing, wood deterioration, or past water damage. No determination could be made regarding the adequacy or condition of the concealed components based on the visible portions at the time of inspection.

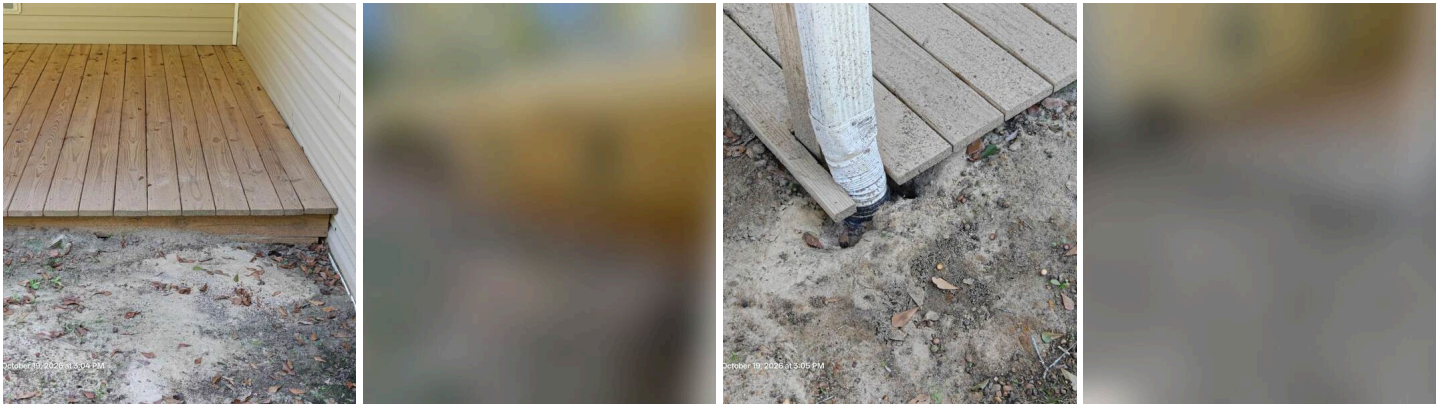
Porch Wood in Contact With Ground

The porch/deck framing and edge boards were observed to be in direct contact with, or very close to, the soil/sandy grade at the perimeter. This condition can trap moisture against the wood and significantly increases the risk of wood decay, fungal growth, and wood-destroying insect activity. Recommend having the porch evaluated by a qualified deck contractor or car-

penter. Improve grading and drainage in this area so water does not collect at the porch edge, and maintain a visible air gap between wood materials and the ground.

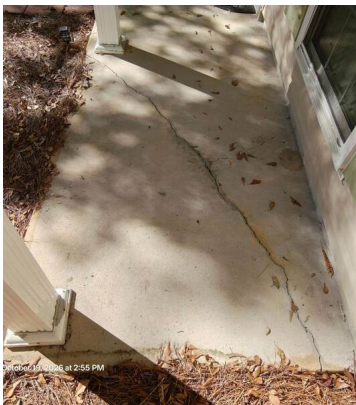
Cracked Concrete Porch/Patio Slab

The concrete porch/patio slab was observed to have visible cracking extending through the walking surface. While minor cracking is common in exterior concrete due to settlement, shrinkage, and seasonal movement, the crack should be monitored for continued widening, displacement, or water intrusion. No significant vertical displacement was visible; Recommend sealing the crack with an appropriate exterior concrete sealant to help reduce water penetration and further deterioration. If movement continues or the crack becomes uneven, a qualified concrete contractor should evaluate and repair as needed.

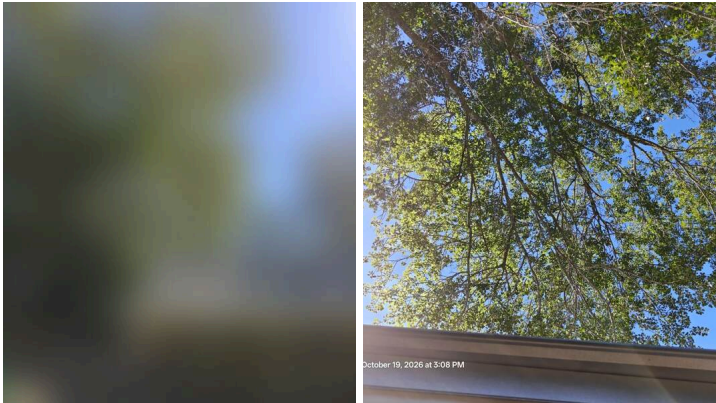
Tree limbs over hang the roof

Tree limbs were observed overhanging the roof surface. Overhanging branches can drop leaves, twigs, and other debris onto the roof and into gutters, which may slow drainage and hold moisture against roofing materials. Limbs that contact or rub against the roof can abrade shingles or other roof coverings, especially during wind movement. Shaded areas beneath tree cover may also remain damp longer, creating conditions that can contribute to moss, algae, or accelerated material deterioration.

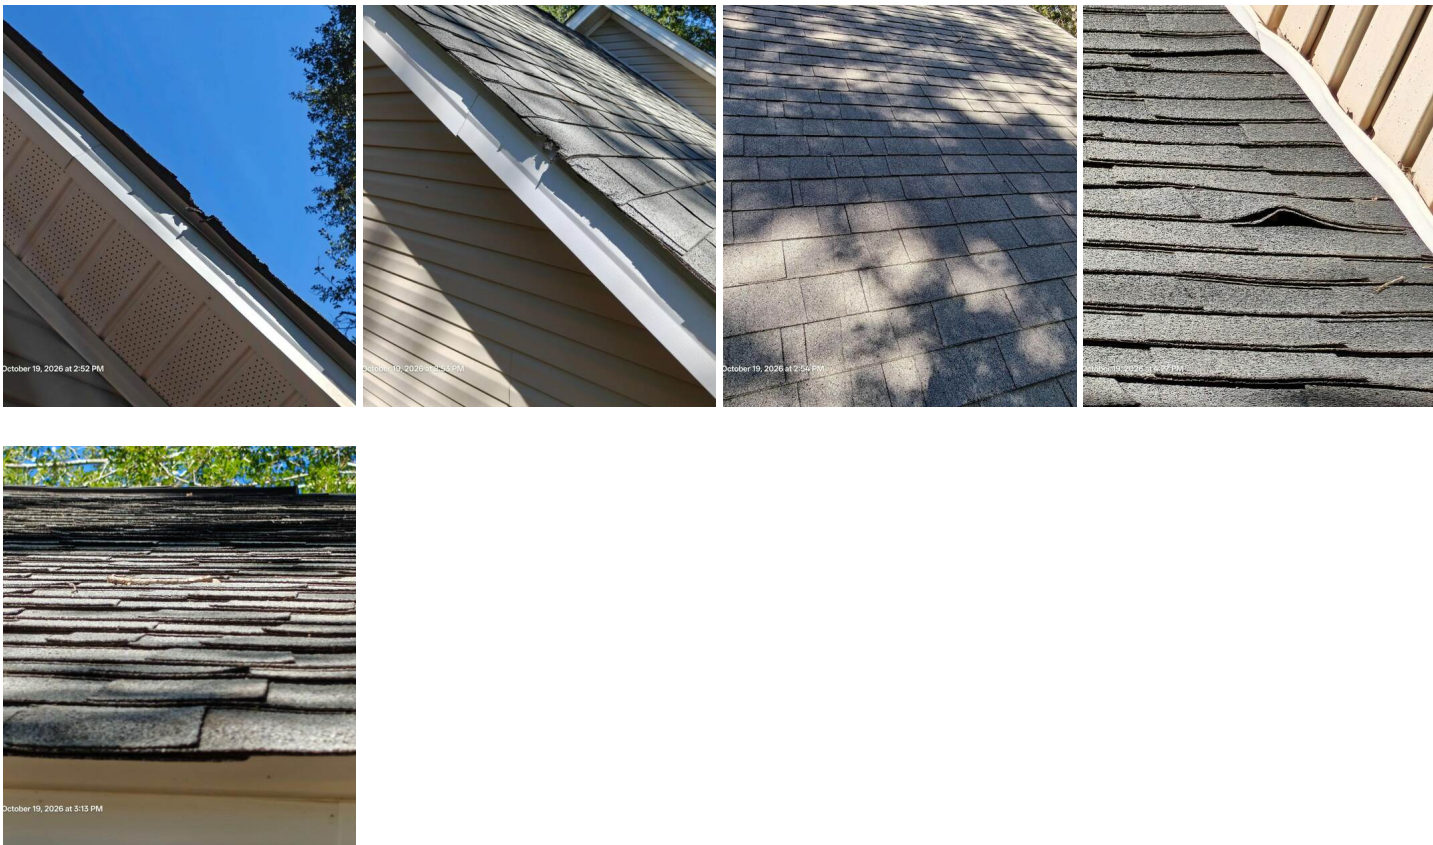
Architectural shingles roof; minor granule loss and the beginning of curling

The architectural asphalt shingles showed minor granule loss and the beginning stages of curling, which are common indicators of normal aging and weather exposure. Granules protect the shingles from UV damage and help shed water, so continued loss can shorten the roof covering's remaining service life. Curling can allow wind-driven rain to get under the shingles and may make them more vulnerable to wind damage over time. Recommend monitoring the roof during routine maintenance and after major storms, keeping gutters and roof surfaces clear of debris, and having a qualified roofing contractor evaluate the roof if deterioration progresses, leaks occur, or shingles become loose or damaged. Budgeting for future roof covering repairs or replacement is advisable as the roof continues to age.

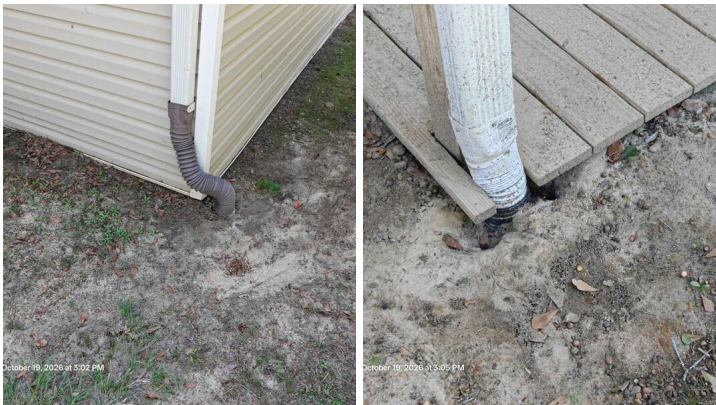
Some downspouts were connected to underground drain piping, and the termination points could not be confirmed during the visual inspection. Because these systems are concealed, their condition, routing, and discharge location are unknown. If underground piping is damaged, clogged, improperly sloped, or discharges too close to the foundation, roof runoff may collect near the building and contribute to soil saturation, basement/crawlspace moisture, foundation movement, or erosion. Properly functioning roof drainage systems are important because they carry a large volume of water away from the structure during rain events.

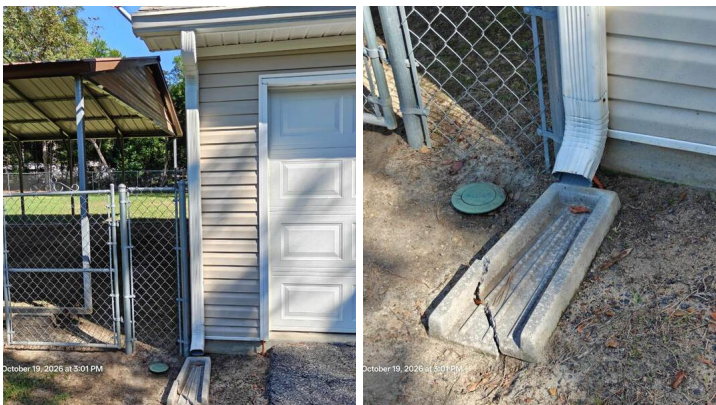
Leader(s) do not extend 6 ft. beyond the foundation perimeter

At the time of inspection, the downspout leaders did not extend at least 6 feet away from the foundation. This condition can allow roof runoff to discharge too close to the structure, increasing the risk of water intrusion, soil saturation, and potential foundation movement or basement/crawlspace moisture issues. It is recommended that the leaders be extended to discharge a minimum of 6 feet away from the foundation, using splash blocks or solid extensions that direct water to a proper drainage area. Ensure extensions slope away from the home and are maintained to remain clear of debris.

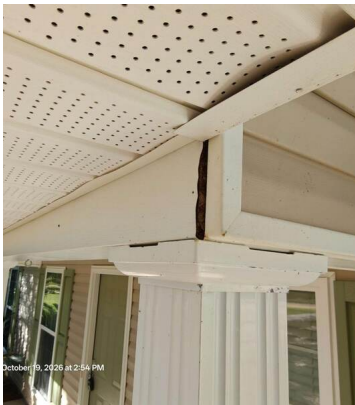
Small area of flashing missing at fascia at corner

A small section of flashing was missing at the fascia corner, leaving this area less protected from wind-driven rain and runoff. Flashing is intended to direct water away from vulnerable roof and trim transitions, and gaps can allow moisture intrusion behind the fascia or into adjacent roof/soffit components. Over time, this may lead to wood rot, paint failure, hidden decay, or potential interior moisture damage if water is able to enter the structure. Recommend repair or replacement of the missing flashing by a qualified roofing contractor to provide a continuous, weather-resistant installation, with any concealed moisture damage evaluated during the repair.

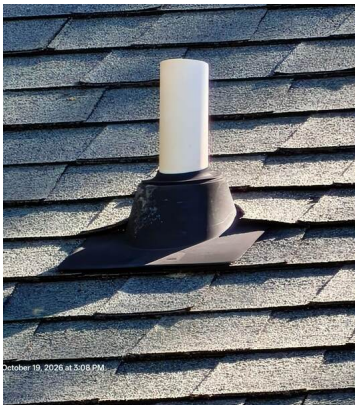
Boot fasteners missing

The plumbing vent boot was observed with missing fasteners, which can allow the boot or flashing to lift, shift, or fail to remain properly sealed against the roof surface. This condition increases the potential for wind-driven rain, moisture intrusion, and hidden roof decking or interior ceiling damage over time. Vent boots are a common roof penetration and depend on proper fastening and sealing to maintain a watertight roof assembly. Recommend repair by a qualified roofing contractor, including installing appropriate corrosion-resistant fasteners and verifying the boot/flashings is properly sealed and in serviceable condition.

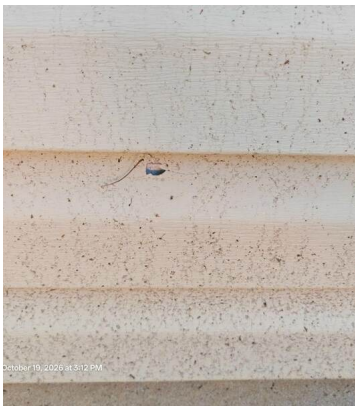
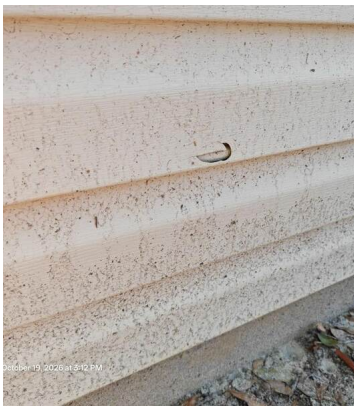
Impact damage: minor

Minor impact damage was observed on the exterior. It's recommended to monitor the area for any signs of worsening damage or water intrusion. Consider repairing to maintain the integrity and appearance of the exterior.

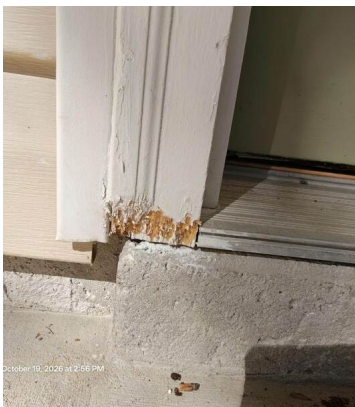
Cosmetic damage noted

Cosmetic damage was noted at the bottom edge of the door frame, consisting of minor scraping. This type of wear is commonly associated with normal use, incidental contact, moving items through the doorway, or minor friction at the lower portion of the frame. The observed condition appeared limited in nature and was not indicative of a structural concern at the time of inspection. If left exposed, scraped finishes can be more susceptible to moisture absorption or further surface deterioration, especially at exterior locations where weather exposure is present.

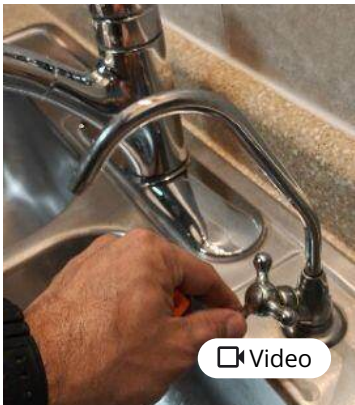
Filter water faucet is loose from sink

The filtered water faucet is loose at the sink and should be secured or repaired by a qualified plumber to prevent leaks and ensure proper operation.

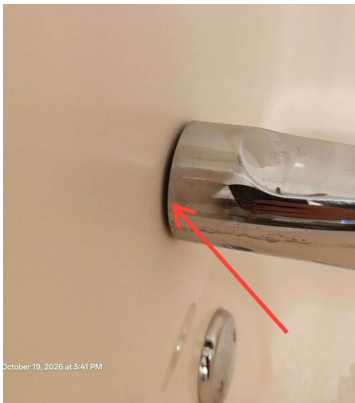
Faucet and/or handles not sealed to wall

The tub/shower faucet and/or handles are not properly sealed to the wall, which could lead to water intrusion and potential water damage. I recommend having a qualified contractor assess and properly seal these components to prevent future issues.

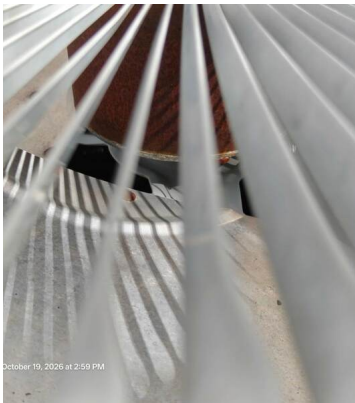
Rust observed

Rust was observed on the exterior unit components, including the fan shroud, fan motor housing, and portions of the internal piping. This condition indicates ongoing exposure to moisture and environmental elements and may contribute to deterioration of the affected components over time. Corrosion can reduce efficiency, impact system performance, and potentially shorten the service life of the equipment if it progresses.

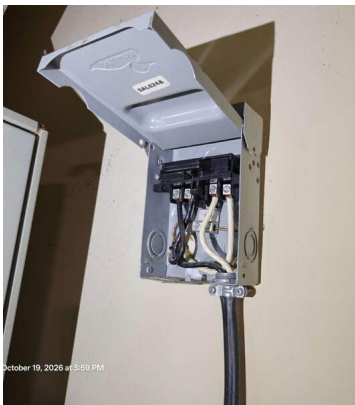
Disconnect switch missing dead front cover

The HVAC disconnect switch is missing its dead front cover, leaving internal electrical components exposed. This condition presents a safety hazard due to the increased risk of accidental contact with energized parts and potential electrical shock. It also allows debris and moisture to enter the enclosure, which can lead to premature equipment failure or further safety concerns. Recommend having a qualified electrician install an appropriate cover or replace the disconnect assembly as needed to restore proper protection and ensure safe operation.

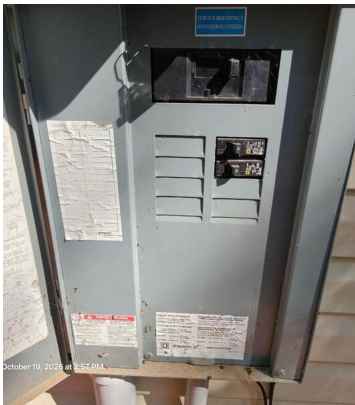
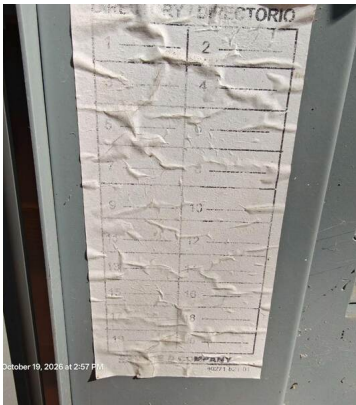
Multiple service disconnects were present, but they were not clearly labeled to identify the equipment or areas they control. Proper labeling is important so occupants, service personnel, or emergency responders can quickly shut off power when needed without confusion or delay. Unlabeled disconnects can create a safety concern during maintenance, troubleshooting, or emergency situations, and may also indicate that the electrical system has not been fully documented after changes or additions. Recommend having a licensed electrician evaluate the service equipment, verify that the disconnects are properly configured, and provide clear, permanent labels for each disconnect.

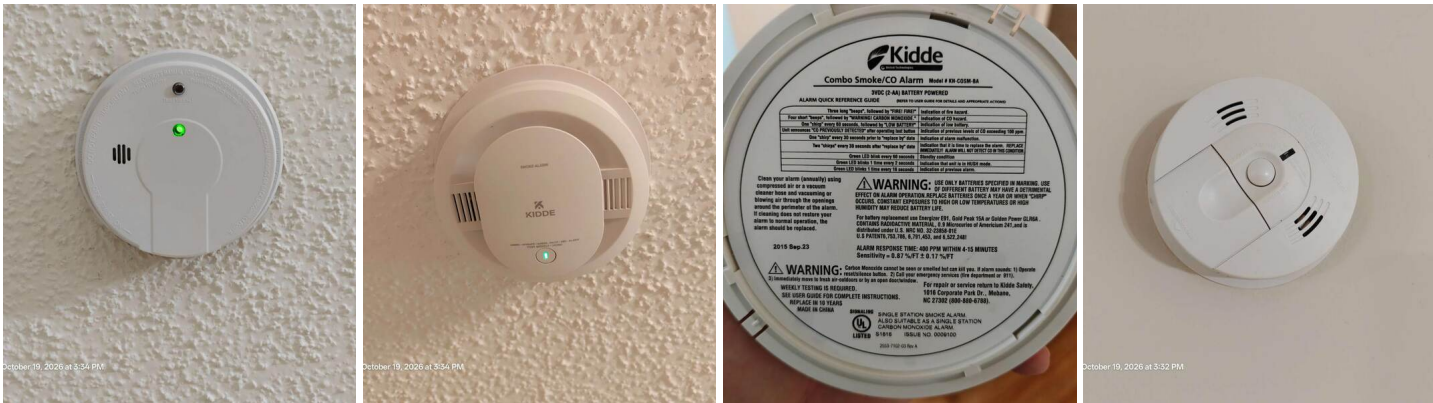
Smoke Detectors Nearing/Past Manufacturer Recommended Lifespan

Smoke detectors observed in the home appear to be approaching or have reached the end of their typical manufacturer-recommended service life, which is commonly around 10 years from the date of manufacture. Aging detectors may not respond as effectively to smoke or fire conditions due to sensor degradation over time. The units were present at the time of inspection; however, their exact age could not be fully verified in all cases.

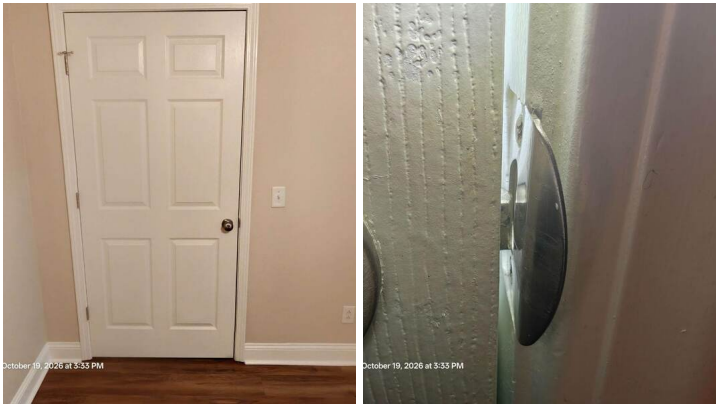
Closet Door not latching; misaligned

rubbing or misalignment can also cause wear to the door edge, latch hardware, or frame over time.

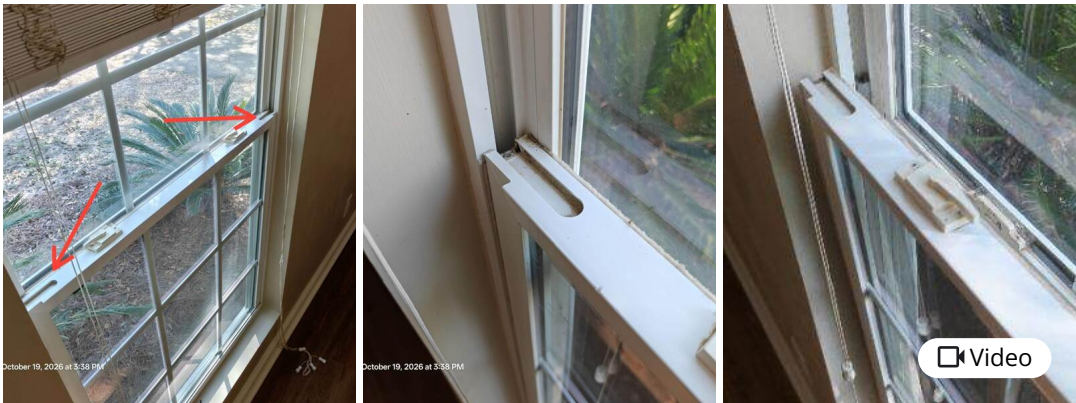
Window tilt mechanism not present

The window tilt mechanism was not present, and the sash would not remain securely in position unless the lock was engaged. Tilt mechanisms are designed to help support, guide, and secure the sash during normal operation and cleaning. When this hardware is missing or nonfunctional, the window may drop, shift, or become difficult to operate, which can create a safety concern and increase the chance of damage to the sash or frame. This condition also indicates that the window is not functioning as intended by the manufacturer.

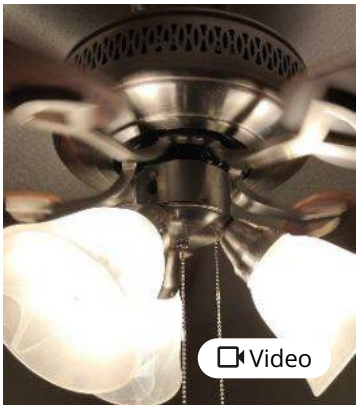
Bedroom Fan making noise

The bedroom fan was making noise during operation, and evaluation/repair by a qualified contractor is recommended.

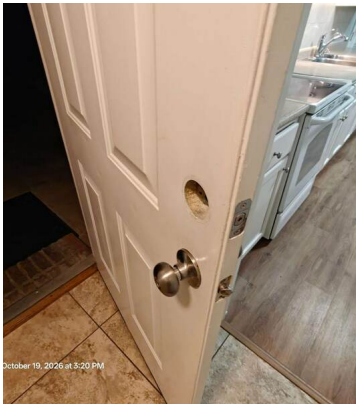
Missing Lock assembly (open hole)

The garage service door was observed with the lock assembly missing, leaving an open hole through the door. This condition can reduce the door's ability to provide proper security and may allow unauthorized access, depending on the door's location and use. The opening may also permit air movement, moisture, insects, or debris to enter the garage. Where the garage is

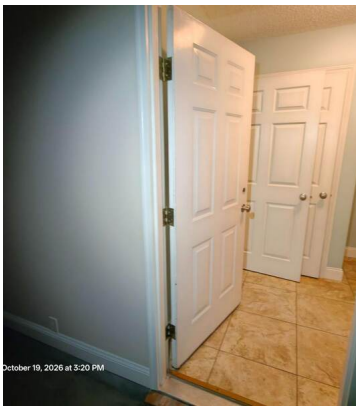
Garage entry door does not have fire rated plate;

During the inspection, it was noted that the garage entry door lacks a visible fire-rated plate, making it difficult to verify if it meets the required fire-rating standards. It's recommended to consult a qualified contractor or door specialist to assess the door's compliance and, if necessary, replace it with a certified fire-rated door to ensure proper safety measures are in place.
