# Home Inspection Report

Mark Bunch / Measure of Confidence In-  
spections LLC

HOME INSPECTION REPORT

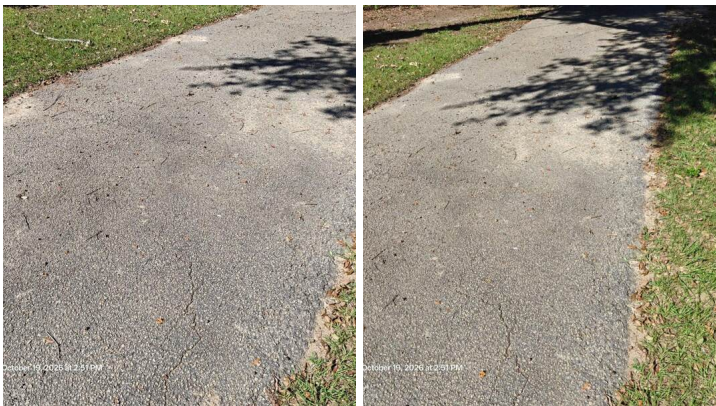
Asphalt Driveway Deterioration and Cracking

The asphalt driveway surface showed visible deterioration, including areas of cracking, surface wear/raveling, and prior patching/unevenness. These conditions are commonly associated with age, weather exposure, and movement/settlement of the base material below the driveway. Cracks and low/uneven areas can allow water to penetrate beneath the asphalt, which may accelerate further deterioration, especially during freeze/thaw cycles. Recommend evaluation by a qualified asphalt contractor for repair options. At minimum, cracks should be cleaned and sealed and deteriorated/uneven areas should be patched as needed to help slow further damage. If deterioration is widespread or the base is unstable, resurfacing or replacement may be necessary. Monitor the driveway for continued settlement, ponding water, or worsening cracks.

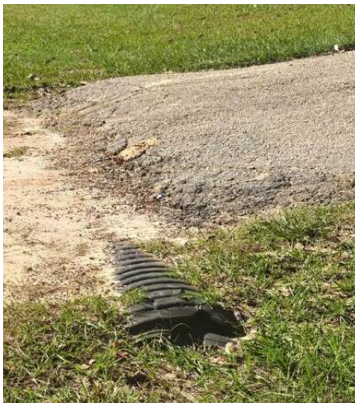
Erosion is present along the edge of the driveway, indicating soil loss and potential undermining of the driveway surface over time. This condition can lead to further deterioration, edge cracking, and reduced structural support if not addressed. It is recommended to have the affected area evaluated and repaired, which may include adding and compacting fill material, improving grading, and implementing drainage control measures to help prevent further erosion. Regular monitoring and maintenance are advised to ensure the condition does not worsen.

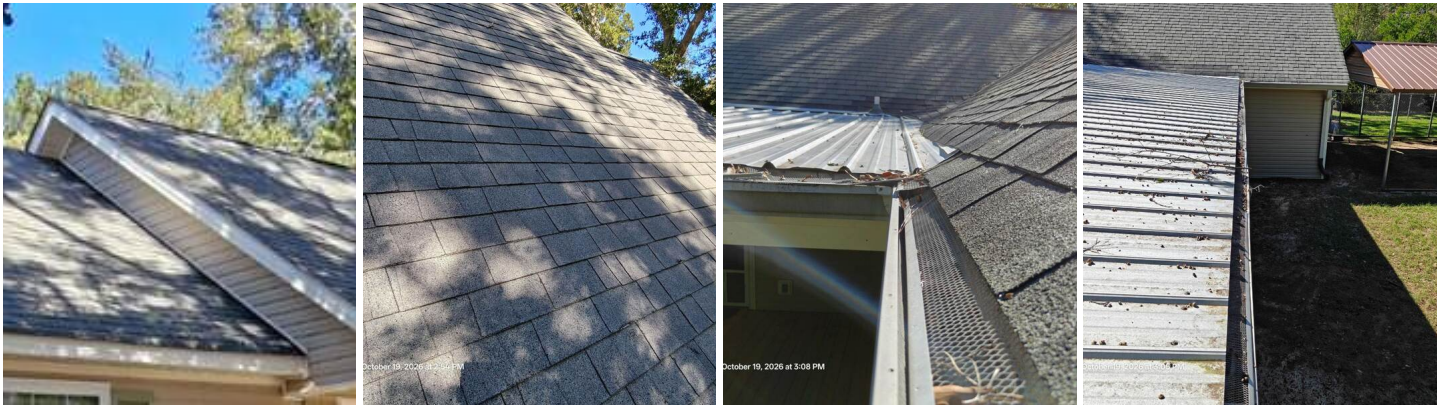
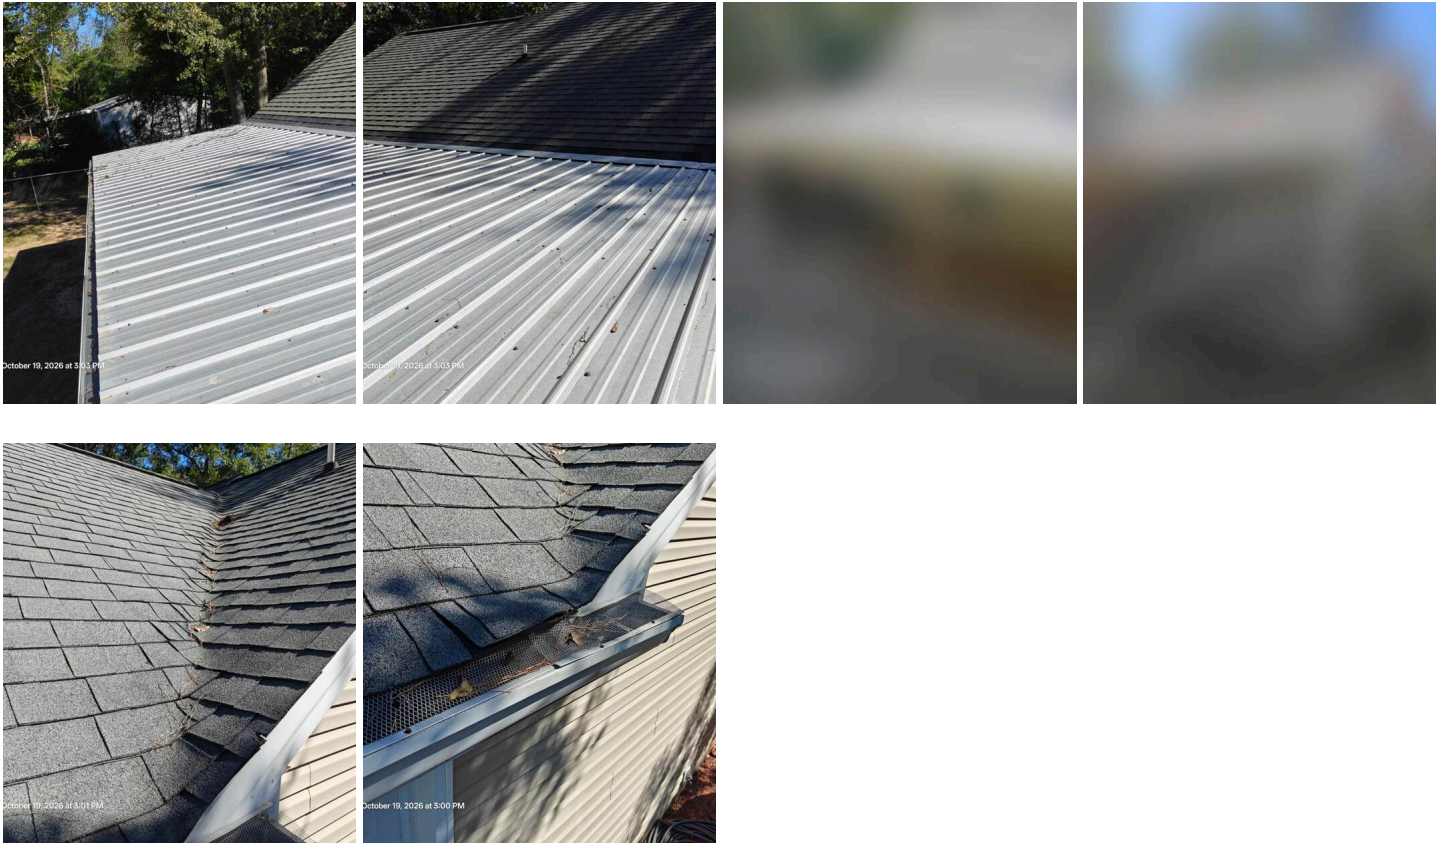
Tree limbs over hang the roof

Tree limbs were observed overhanging the roof surface. Overhanging branches can drop leaves, twigs, and other debris onto the roof and into gutters, which may slow drainage and hold moisture against roofing materials. Limbs that contact or rub against the roof can abrade shingles or other roof coverings, especially during wind movement. Shaded areas beneath tree cover may also remain damp longer, creating conditions that can contribute to moss, algae, or accelerated material deterioration.

The architectural asphalt shingles showed minor granule loss and the beginning stages of curling, which are common indicators of normal aging and weather exposure. Granules protect the shingles from UV damage and help shed water, so continued loss can shorten the roof covering's remaining service life. Curling can allow wind-driven rain to get under the shingles and may make them more vulnerable to wind damage over time. Recommend monitoring the roof during routine maintenance and after major storms, keeping gutters and roof surfaces clear of debris, and having a qualified roofing contractor evaluate the roof if deterioration progresses, leaks occur, or shingles become loose or damaged. Budgeting for future roof covering repairs or replacement is advisable as the roof continues to age.

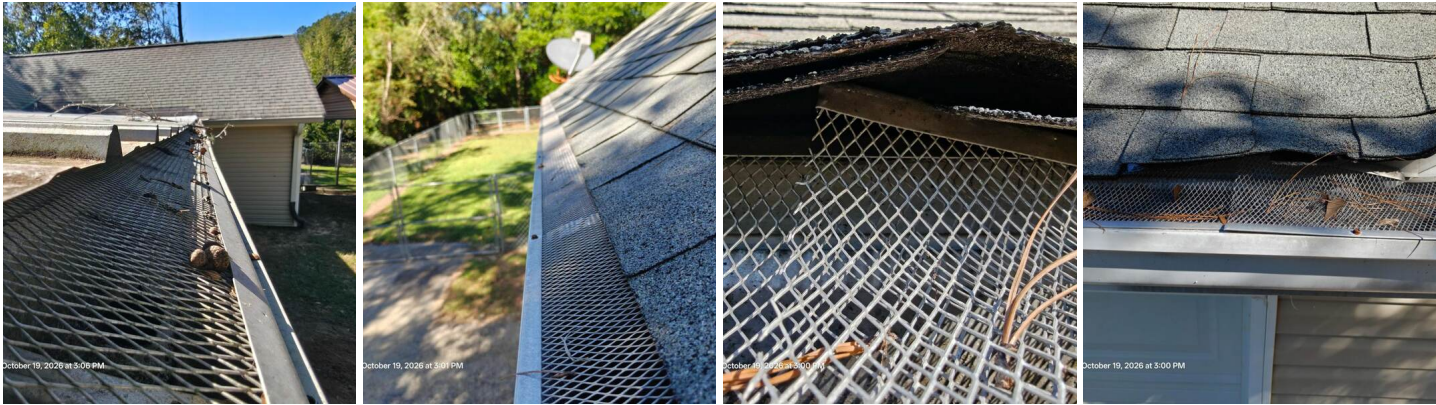
Gutter installed in specific areas only; not full install

Leader(s) do not extend 6 ft. beyond the foundation perimeter

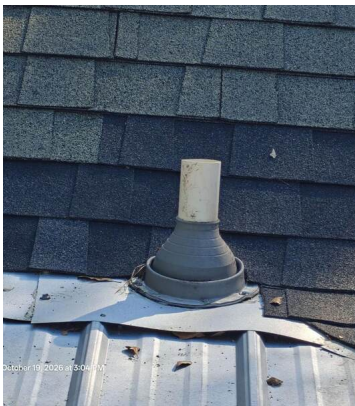
Boot fasteners missing

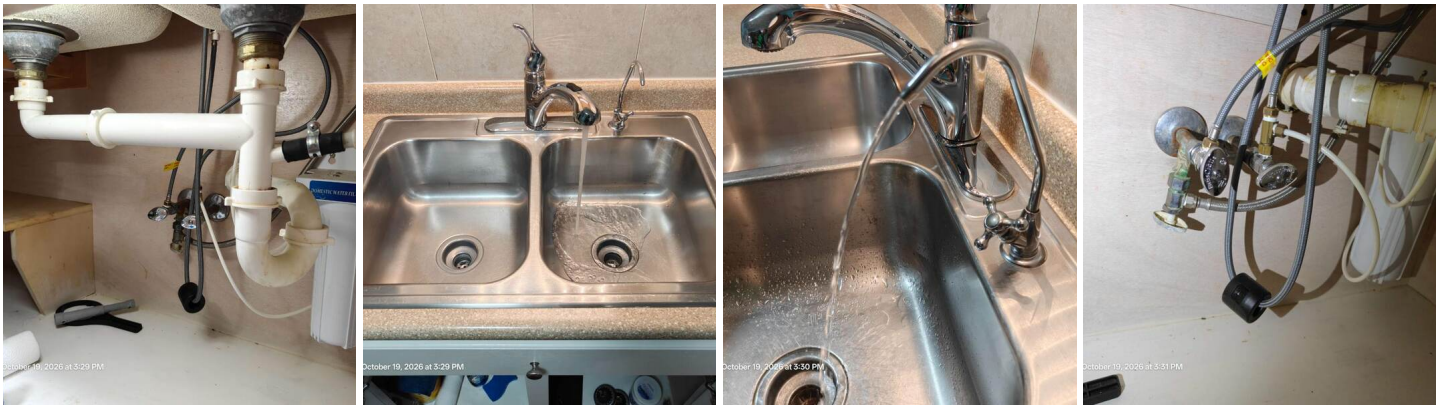
Filter water faucet is loose from sink

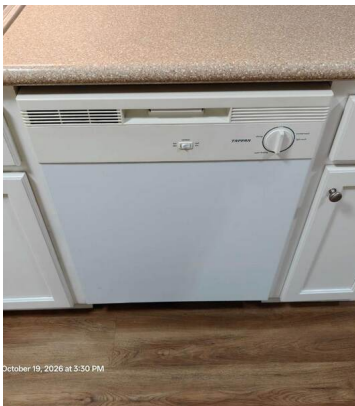
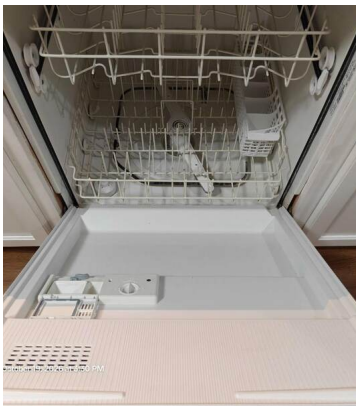
Inoperative at time of inspection

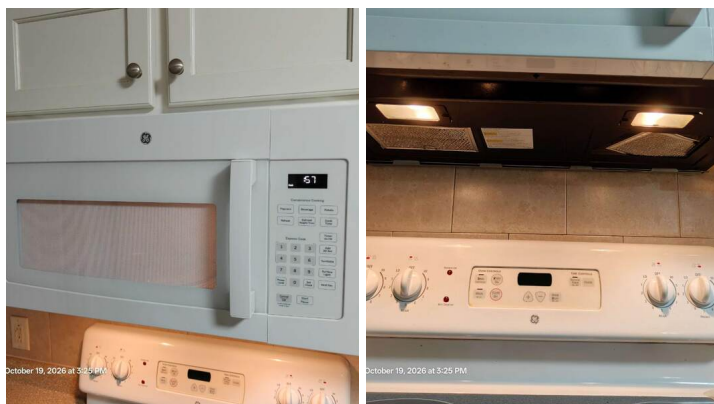
### Microwave Exhaust Vent Improperly Configured

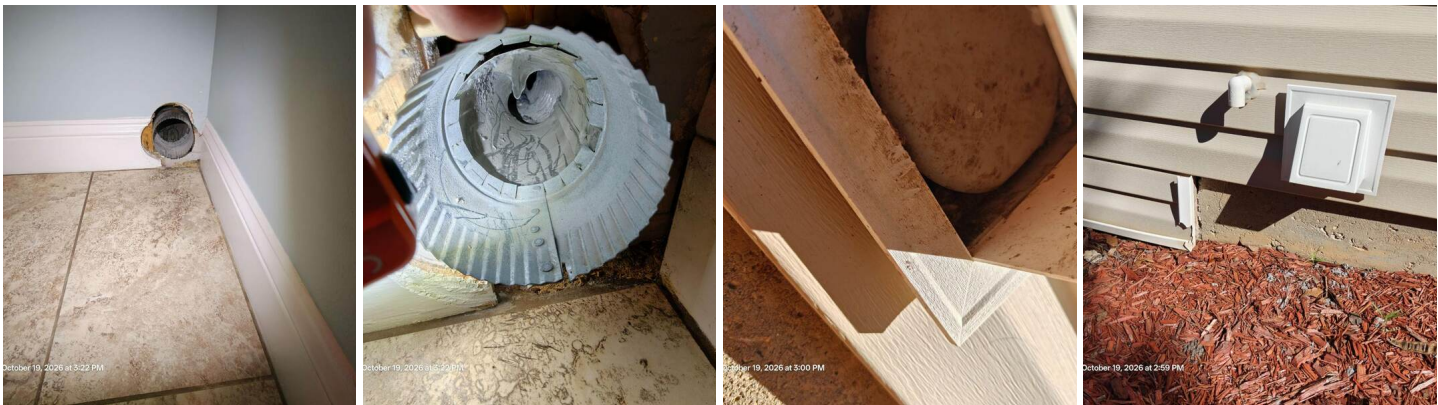
Dryer Vent Maintenance

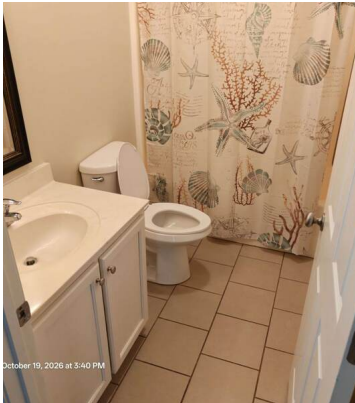
Cabinet door has crack in stile at hinges

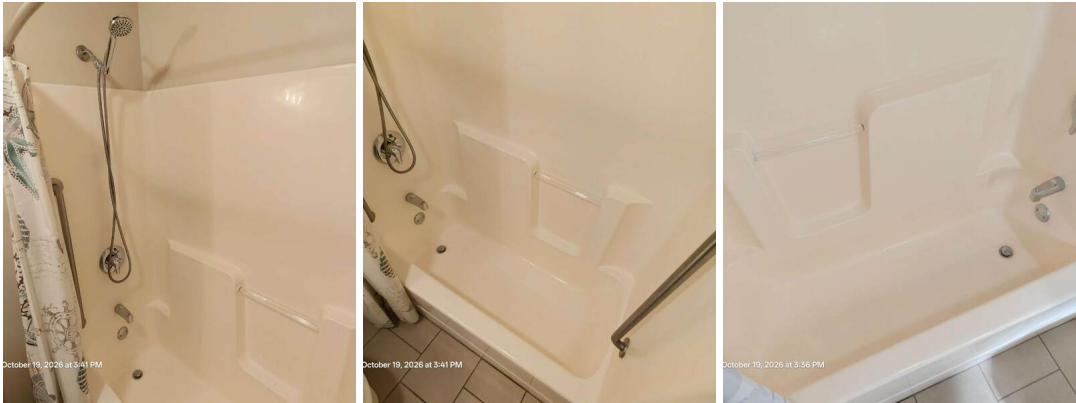
Faucet and/or handles not sealed to wall

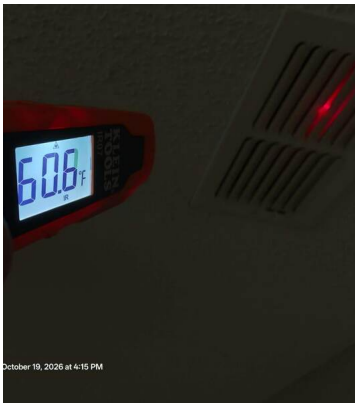
Cool Discharge

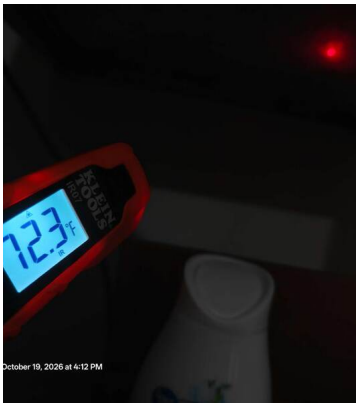
Cool intake

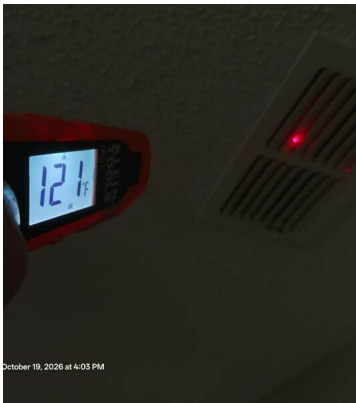
Heat discharge

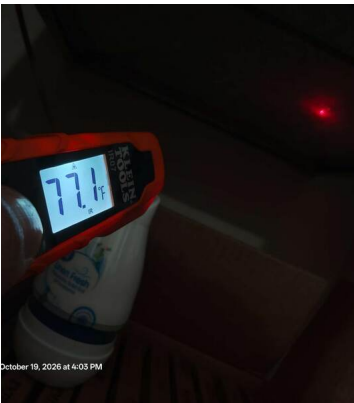
Heat intake

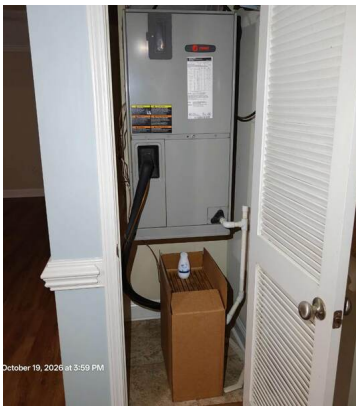
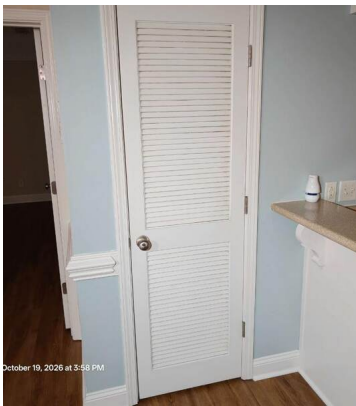
Year of Manufacture 2006 (19 YRS OLD)

The heating/cooling system was manufactured in 2006, making it approximately 19 years old at the time of inspection. This places the equipment at or beyond the typical expected service life for many HVAC systems, which is often around 15–20 years depending on installation quality, maintenance history, usage, and operating conditions. Older systems are more likely to experience declining efficiency, increased operating costs, reduced reliability, and more frequent component failures. Replacement parts may also become harder to obtain as equipment ages, and performance may not meet current efficiency standards.

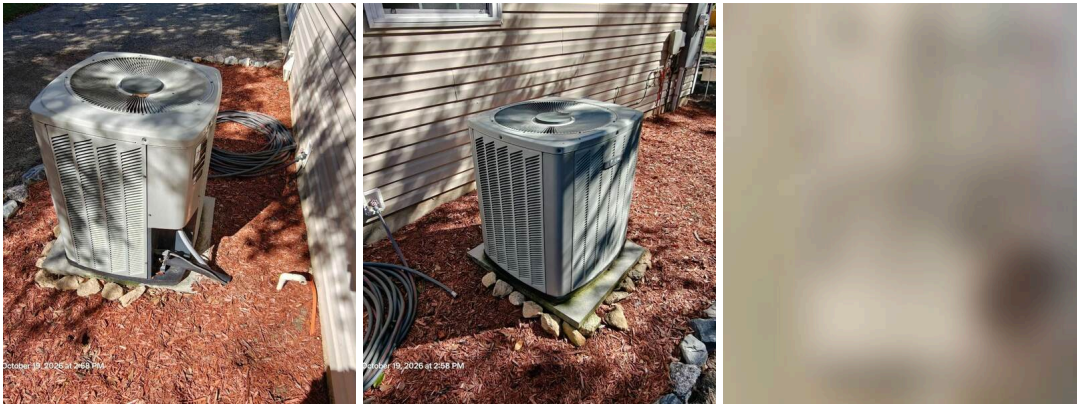
Rust observed

Rust was observed on the exterior unit components, including the fan shroud, fan motor housing, and portions of the internal piping. This condition indicates ongoing exposure to moisture and environmental elements and may contribute to deterioration of the affected components over time. Corrosion can reduce efficiency, impact system performance, and potentially shorten the service life of the equipment if it progresses.

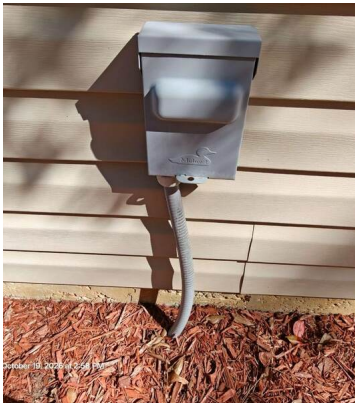
Disconnect switch missing dead front cover

The HVAC disconnect switch is missing its dead front cover, leaving internal electrical components exposed. This condition presents a safety hazard due to the increased risk of accidental contact with energized parts and potential electrical shock. It also allows debris and moisture to enter the enclosure, which can lead to premature equipment failure or further safety concerns. Recommend having a qualified electrician install an appropriate cover or replace the disconnect assembly as needed to restore proper protection and ensure safe operation.

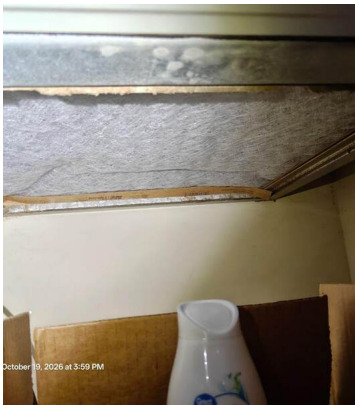
The air filter requires maintenance; as it gets dirty it and can restrict airflow. I recommend replacing the filter to ensure optimal HVAC performance and improve indoor air quality. Regular maintenance every 1-3 months is advisable.

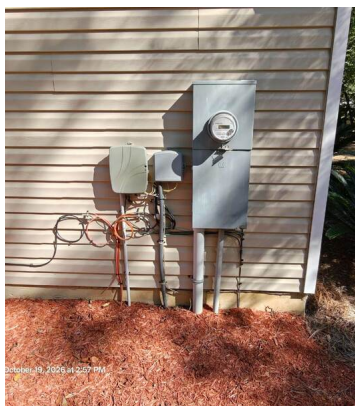
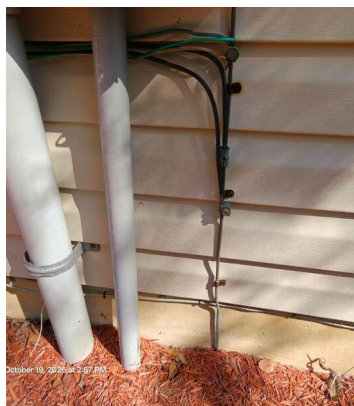
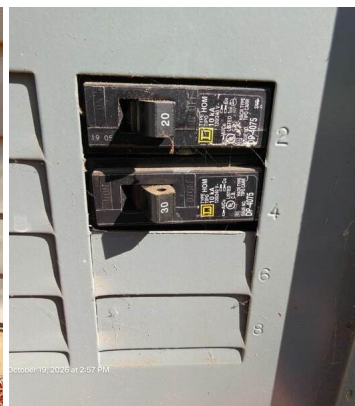
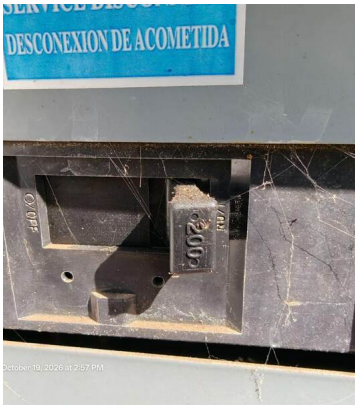
Multiple Service Disconnects: not labled

Multiple service disconnects were present, but they were not clearly labeled to identify the equipment or areas they control. Proper labeling is important so occupants, service personnel, or emergency responders can quickly shut off power when needed without confusion or delay. Unlabeled disconnects can create a safety concern during maintenance, troubleshooting, or emergency situations, and may also indicate that the electrical system has not been fully documented after changes or additions. Recommend having a licensed electrician evaluate the service equipment, verify that the disconnects are properly configured, and provide clear, permanent labels for each disconnect.

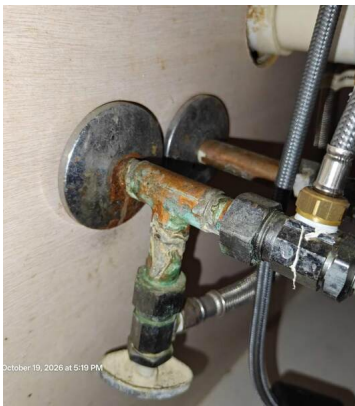
Finishes block visual inspection of water line(s)

During the inspection, visibility of the water lines was obstructed by finishes. Although a comprehensive visual inspection could not be completed, the portions that were accessible appear to be in serviceable condition.

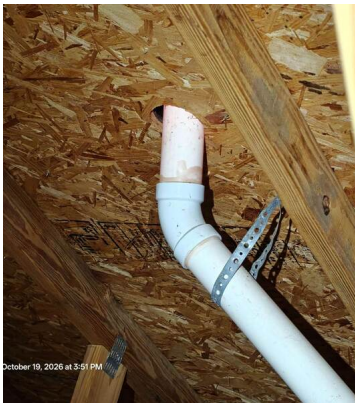
Finishes block visual inspection of vent line(s)

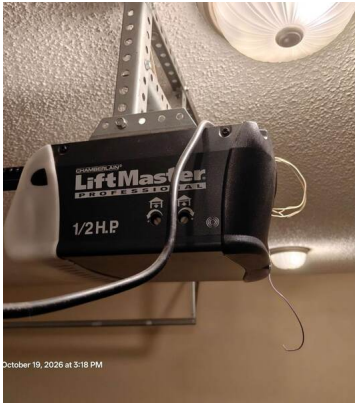
Appears Serviceable

The garage door opener appears serviceable with no visible defects or operational issues noted at the time of inspection. Regular maintenance, such as lubricating moving parts and testing safety features, is recommended to ensure continued functionality and safety.

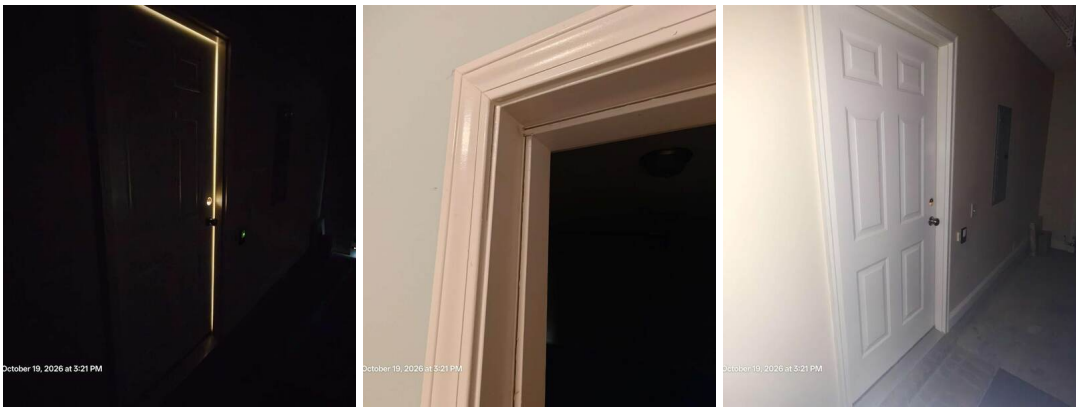
Door missing weatherseals

The garage service door was missing weatherseals at the perimeter. Weatherseals help limit air leakage, wind-driven rain, dust, insects, and small pests from entering the garage. Gaps around the door can also contribute to drafts and temperature fluctuations, which may affect comfort and energy efficiency in adjacent areas. If this door separates the garage from the living space, missing seals can also reduce the effectiveness of the separation intended to help limit the movement of vehicle exhaust, odors, and other garage-related contaminants.

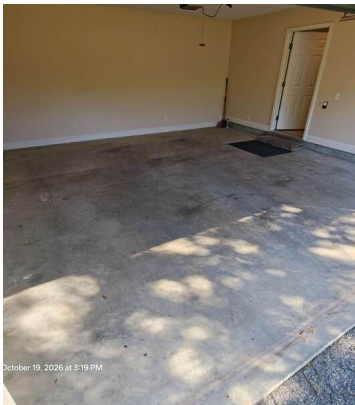
Appears Serviceable

Garage floor and foundation appear to be in serviceable condition with no major issues.

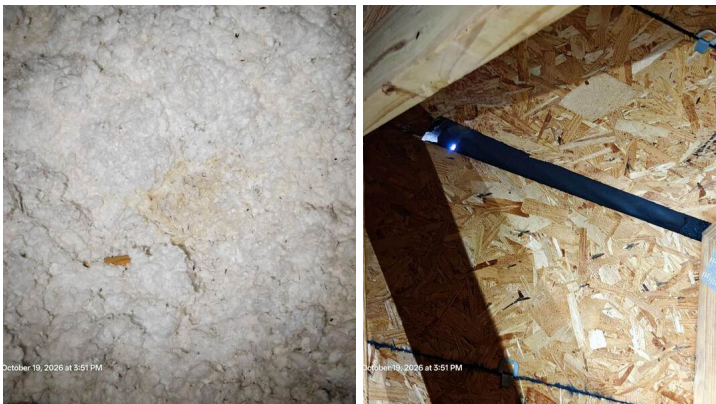
A small hole was observed near the edge of the ridge vent, with localized discoloration of the insulation below indicating minor moisture entry or a relatively recent leak. No widespread staining or significant damage was visible at the time of inspection, but even small roof penetrations can allow water intrusion during wind-driven rain and may worsen over time if not corrected. The ridge vent area is vulnerable because it is exposed to weather and relies on proper installation and intact roofing materials to shed water. Recommend having a qualified roofing contractor evaluate and repair the hole and surrounding ridge vent materials, then monitor the attic insulation and roof sheathing for any further signs of moisture after heavy rain.

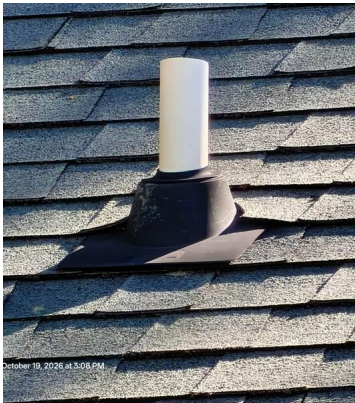
3.6 PLUMBING VENTS

Boot fasteners missing

The plumbing vent boot was observed with missing fasteners, which can allow the boot or flashing to lift, shift, or fail to remain properly sealed against the roof surface. This condition increases the potential for wind-driven rain, moisture intrusion, and hidden roof decking or interior ceiling damage over time. Vent boots are a common roof penetration and depend on proper fastening and sealing to maintain a watertight roof assembly. Recommend repair by a qualified roofing contractor, including installing appropriate corrosion-resistant fasteners and verifying the boot/flashing is properly sealed and in serviceable condition.

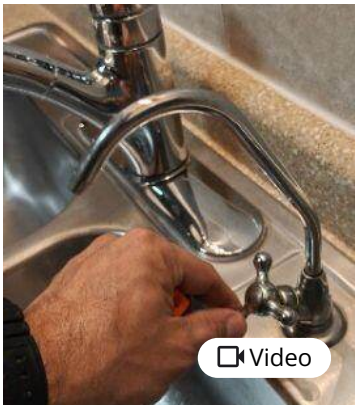
5.4 PLUMBING/FIXTURES

Filter water faucet is loose from sink

The filtered water faucet is loose at the sink and should be secured or repaired by a qualified plumber to prevent leaks and ensure proper operation.

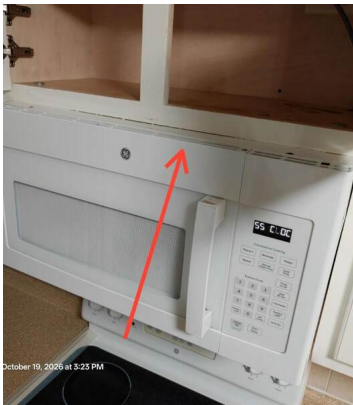
5.7 MICROWAVE - BUILT-IN

Microwave Exhaust Vent Improperly Configured

The built-in microwave exhaust fan was configured for exterior venting, but no exterior duct or termination was observed. In this setup, cooking exhaust may be directed into an enclosed cabinet, wall cavity, or other unintended area rather than being discharged outdoors or filtered back into the kitchen. This can allow heat, moisture, grease, and cooking odors to accumulate in concealed spaces, which may contribute to staining, odors, cabinet deterioration, or microbial growth over time. Many over-the-range microwaves are designed to be convertible between exterior venting and recirculating operation, but the blower orientation and filter setup must match the actual installation.

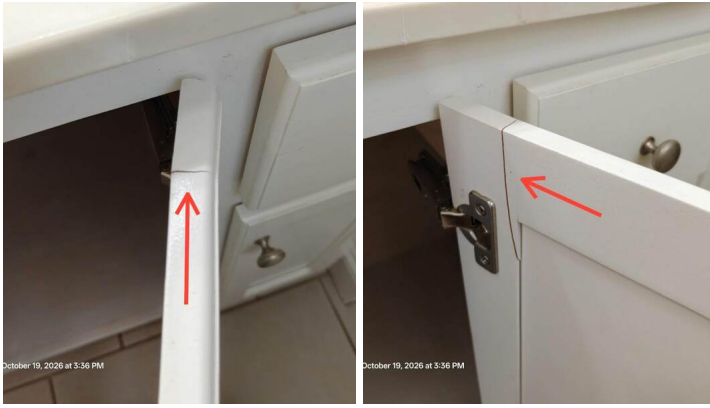
### 7.1 COUNTER/CABINET

Cabinet door has crack in stile at hinges

The cabinet door stile is cracked at the hinge locations, which can weaken the hinge attachment and affect the door's alignment and operation. This type of damage often occurs from repeated stress, loose hardware, moisture exposure, or over-tightened hinge screws. If not repaired, the crack may worsen and the door could become loose, sag, or detach from the cabinet. Recommend repair or replacement of the damaged door/stile by a qualified cabinet or finish carpenter, and the hinges should be re-secured as needed to restore proper function.

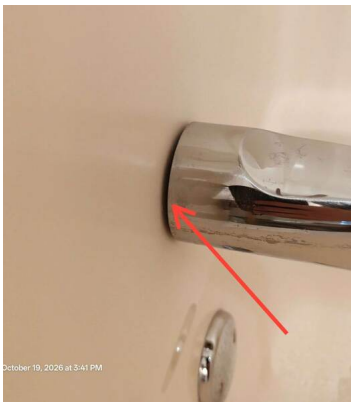
## 7.5 TUB/SHOWER/SURROUND

The tub/shower faucet and/or handles are not properly sealed to the wall, which could lead to water intrusion and potential water damage. I recommend having a qualified contractor assess and properly seal these components to prevent future issues.

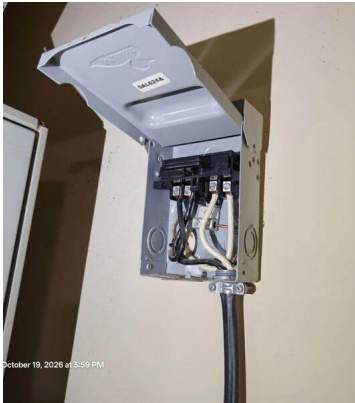
### 8.4 SERVICE AND SAFETY CONTROLS

Disconnect switch missing dead front cover

The HVAC disconnect switch is missing its dead front cover, leaving internal electrical components exposed. This condition presents a safety hazard due to the increased risk of accidental contact with energized parts and potential electrical shock. It also allows debris and moisture to enter the enclosure, which can lead to premature equipment failure or further safety concerns.

Recommend having a qualified electrician install an appropriate cover or replace the disconnect assembly as needed to restore proper protection and ensure safe operation.

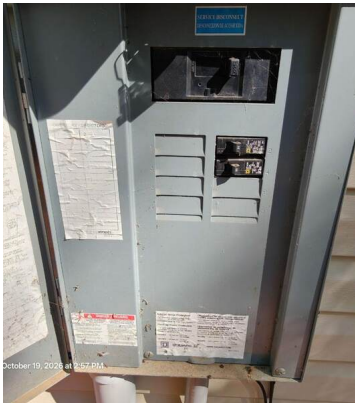
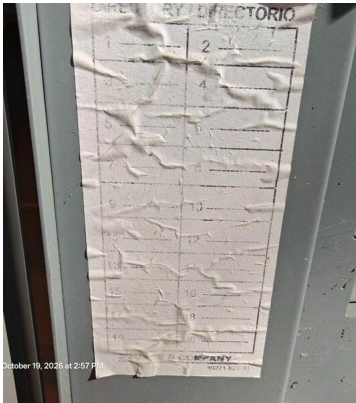
### 9.1 SERVICE

Multiple Service Disconnects: not labled

Multiple service disconnects were present, but they were not clearly labeled to identify the equipment or areas they control. Proper labeling is important so occupants, service personnel, or emergency responders can quickly shut off power when needed without confusion or delay. Unlabeled disconnects can create a safety concern during maintenance, troubleshooting, or emergency situations, and may also indicate that the electrical system has not been fully documented after changes or additions. Recommend having a licensed electrician evaluate the service equipment, verify that the disconnects are properly configured, and provide clear, permanent labels for each disconnect.

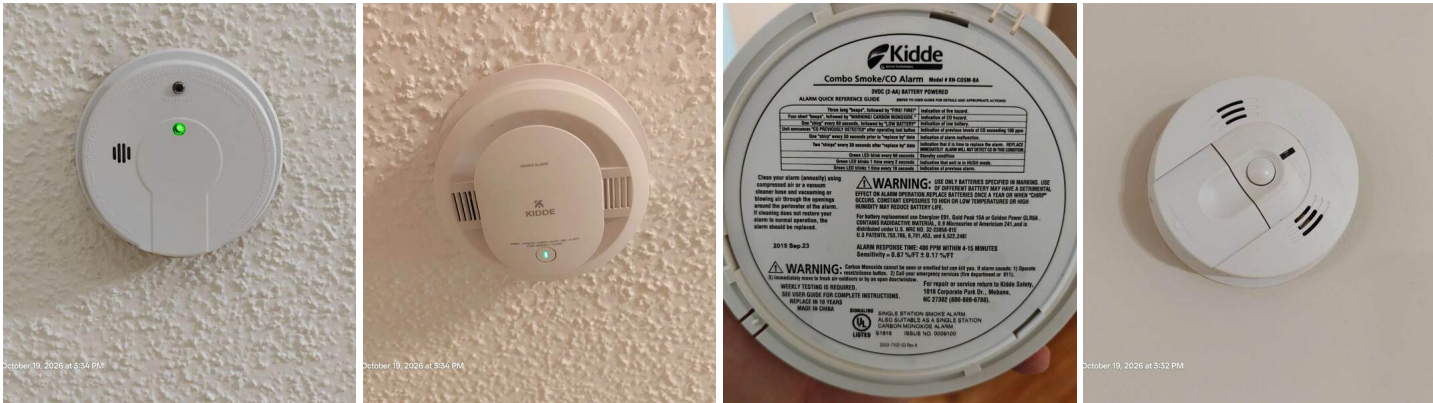
9.5 SMOKE / CARBON MONOXIDE DETECTORS

Smoke Detectors Nearing/Past Manufacturer Recommended Lifespan

Smoke detectors observed in the home appear to be approaching or have reached the end of their typical manufacturer-recommended service life, which is commonly around 10 years from the date of manufacture. Aging detectors may not respond as effectively to smoke or fire conditions due to sensor degradation over time. The units were present at the time of inspection; however, their exact age could not be fully verified in all cases.

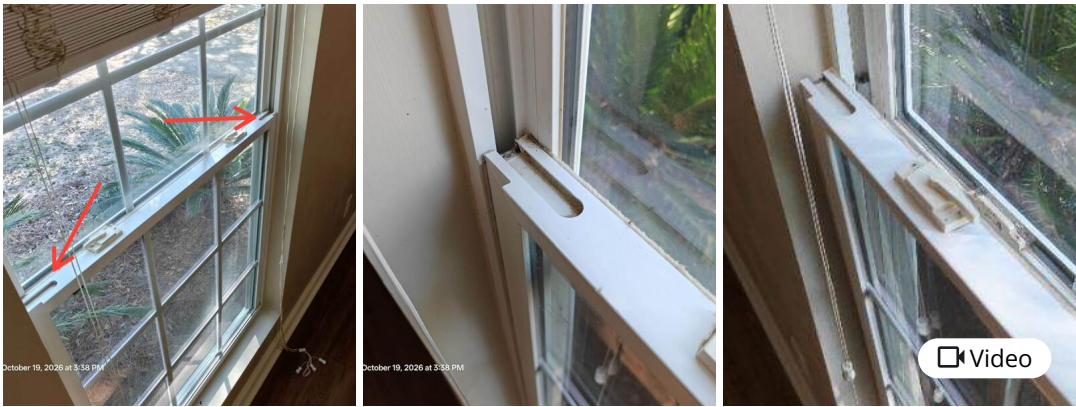
The window tilt mechanism was not present, and the sash would not remain securely in position unless the lock was engaged. Tilt mechanisms are designed to help support, guide, and secure the sash during normal operation and cleaning. When this hardware is missing or nonfunctional, the window may drop, shift, or become difficult to operate, which can create a safety concern and increase the chance of damage to the sash or frame. This condition also indicates that the window is not functioning as intended by the manufacturer.

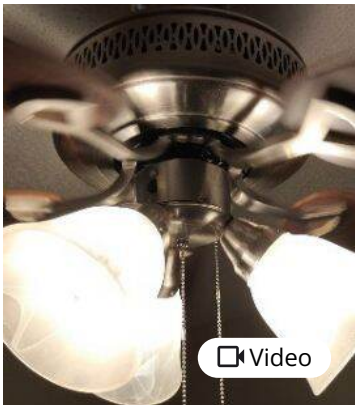
Bedroom Fan making noise

The bedroom fan was making noise during operation, and evaluation/repair by a qualified contractor is recommended.

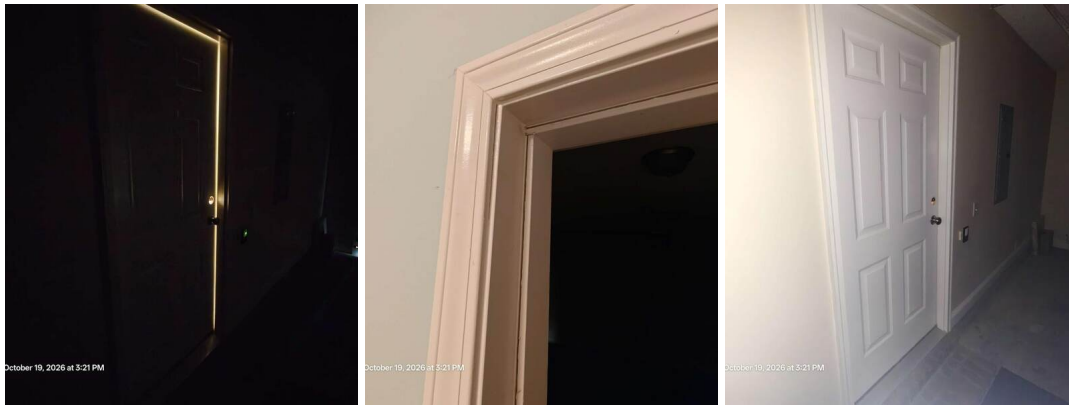
12.4 SERVICE DOORS

Door missing weatherseals

The garage service door was missing weatherseals at the perimeter. Weatherseals help limit air leakage, wind-driven rain, dust, insects, and small pests from entering the garage. Gaps around the door can also contribute to drafts and temperature fluctuations, which may affect comfort and energy efficiency in adjacent areas. If this door separates the garage from the living space, missing seals can also reduce the effectiveness of the separation intended to help limit the movement of vehicle exhaust, odors, and other garage-related contaminants.

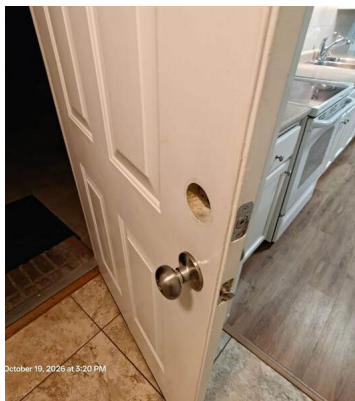
#### Missing Lock assembly (open hole)

The garage service door was observed with the lock assembly missing, leaving an open hole through the door. This condition can reduce the door's ability to provide proper security and may allow unauthorized access, depending on the door's location and use. The opening may also permit air movement, moisture, insects, or debris to enter the garage. Where the garage is attached to the home, gaps or openings in service doors can also affect the intended separation between the garage and living space.

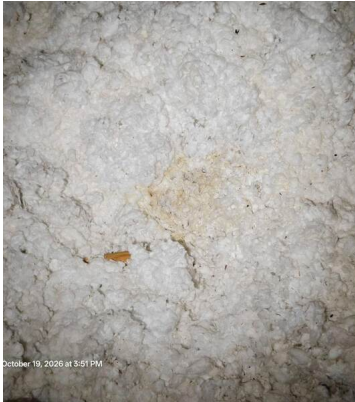
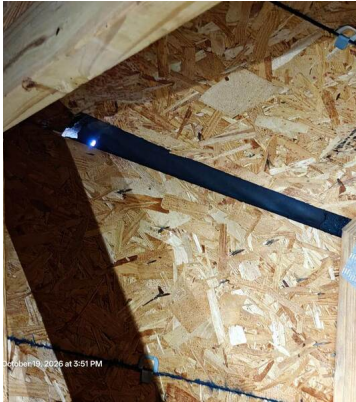
### 13.5 MOISTURE PENETRATION

A small hole was observed near the edge of the ridge vent, with localized discoloration of the insulation below indicating minor moisture entry or a relatively recent leak. No widespread staining or significant damage was visible at the time of inspection, but even small roof penetrations can allow water intrusion during wind-driven rain and may worsen over time if not corrected. The ridge vent area is vulnerable because it is exposed to weather and relies on proper installa-

tion and intact roofing materials to shed water. Recommend having a qualified roofing contractor evaluate and repair the hole and surrounding ridge vent materials, then monitor the attic insulation and roof sheathing for any further signs of moisture after heavy rain.
